Evaluation of a Decoupling-Based Fault Detection and Diagnostic Technique –

Part II: Field Evaluation and Application

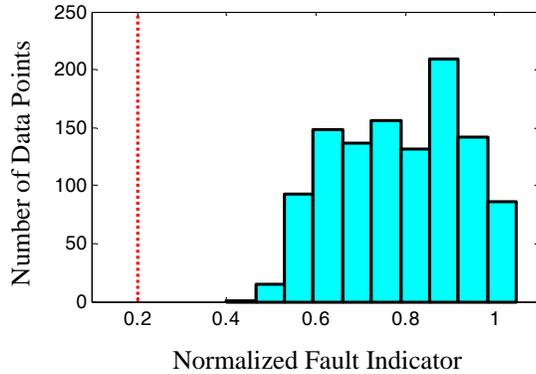
Fig. 1 Liquid-line restriction indicator distribution

Fig. 1, 2, 3, 4 and 5 show normalized fault indicators for the five different faults considered in this study. Fig. 1 gives normalized fault indicators for a liquid-line restriction fault. All the steady-state data points are located at the right of the red dotted FDD threshold line and the mean value is around 0.8. That is, all steady-state points indicate that the liquid-line was restricted. Most likely the filter or drier is clogged with debris. If this fault happened individually, it would result in about a 16% cooling capacity degradation.

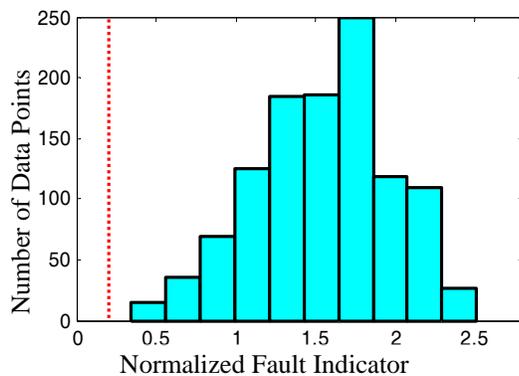
Fig. 2 Refrigerant low charge indicator distribution

Fig. 2 plots the normalized fault indicator for refrigerant charge faults. Similar to Fig. 1, all of the steady-state data points are located to the right of the FDD threshold and the mean value is about 1.6, which means that the system charge is very low. If this fault happened individually, it would result in about a 32% cooling capacity degradation.

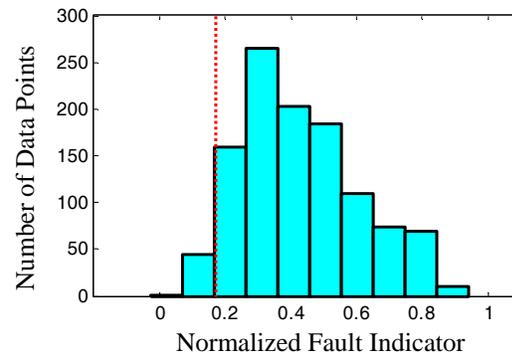
Fig. 3 Condenser fouling indicator distribution

Fig. 3 plots the normalized fault indicator for a condenser fouling fault. Most of the steady-state data points (>95%) are to the right of the FDD threshold and the mean value is about 0.5, which indicates that the condenser is a little dirty. If this fault happened individually, it would result in about 10% cooling capacity degradation.

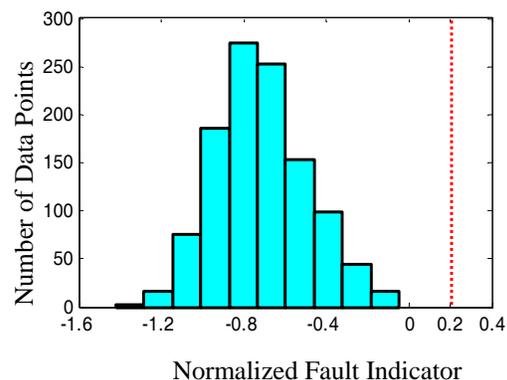
Fig. 4 Compressor leakage indicator distribution

Fig. 4 plots the normalized fault indicator for a compressor valve leakage fault. All the steady-state data points are to the left of the FDD threshold and the mean value is about -0.7, which indicates that the compressor is working properly and the compressor has about 15% heat loss. However, according to heat transfer analysis and our experience with laboratory data, compressors installed in packaged RTUs have very small heat loss, less than 5% of the power input and even gain some heat at some operating conditions. The explanation for this discrepancy is probably that the discharge line temperature is not measured accurately using the RTD temperature sensor. Li ^[4] investigated the RTD measuring issue and presented a correction approach. However, there is evidence obtained from a site visit that the discharge line temperature sensor is not probably installed or insulated.

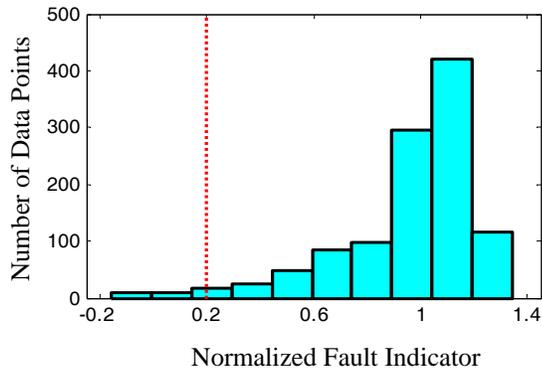
Fig. 5 Evaporator fouling indicator distribution

The normalized fault indicator for the evaporator fouling fault is plotted in Fig. 5. Most of the steady-state data points are at the right of the FDD threshold and the mean value is about 0.96, which indicates that the evaporator is dirty. If this fault occurs individually, it would result in about 19% cooling capacity degradation.

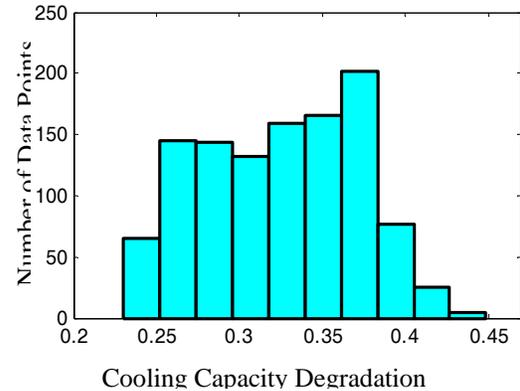
Fig. 6 Cooling capacity degradation distribution

Fig. 6 plots the cooling capacity degradation associated with the combination of these faults for the case study site. The system cooling capacity is degraded 23~45% (average of about 32%), which is consistent with the degradation that would be determined for solely for the low refrigerant charge fault. This is because the low charge fault is a system-level fault which is not completely decoupled from other component-level faults and thus its indicator reflects the impact of other faults. The cooling capacity degradation is consistent with the return air temperature and system runtime. It can be seen from Fig. 7 that the average return air temperature is around 78 F and the highest is 88 F, which means that this equipment does not maintain comfortable space conditions much of the time. From Fig. 8, it can be seen that the system ran continuously for long periods of time (average of 2.5 hours, maximum of 9 hours). So, based on a comfort criterion, service should have been done to correct the diagnosed faults.

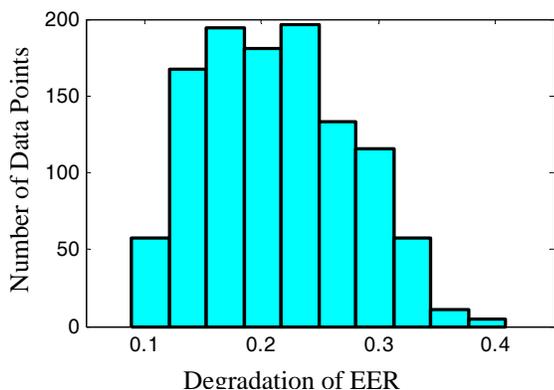
Fig. 9 EER degradation distribution

Fig. 9 plots an economic criterion for service, EER degradation. It can be seen that the system EER degrades between about 10~40%, depending on the operating conditions. Compared with the cooling capacity degradation, the EER degradation is a little smaller. Fig. 10 plots the system power consumption reduction. The average power consumption reduction is about 15%, which is smaller than the average cooling capacity degradation of 32%. The average degradation in EER is 21%.

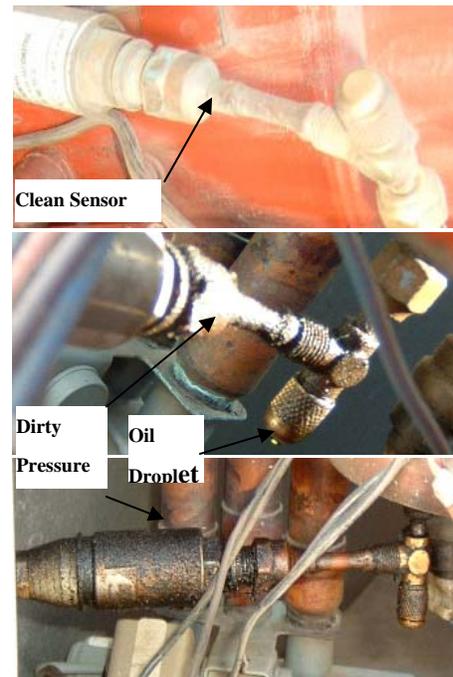
For refrigerant leakage, visual evidence appears as lubricant residual at piping connections or fittings. For example, Fig. 11 gives some snapshots taken at field sites that indicate leakage occurred at the pressure sensor fittings. Fig. 12 shows a case where leakage occurs at the brazed or welded areas of condenser tube bends. Fig. 13 shows another leakage case which occurs at the compressor service ports. Tab. 5 summarizes the earlier diagnoses based upon sensor readings and the on-site evidence for refrigerant leakage. Most of the cases are confirmed by visual signs of lubricant leakage. However, lubricant leakage is only a sufficient condition for refrigerant leakage and not a necessary condition. Refrigerant leakage could occur without visual evidence. What's more, the refrigerant charge could be low due to inadequate charging at the time of

Fig. 11 Pressure sensor fitting leakage

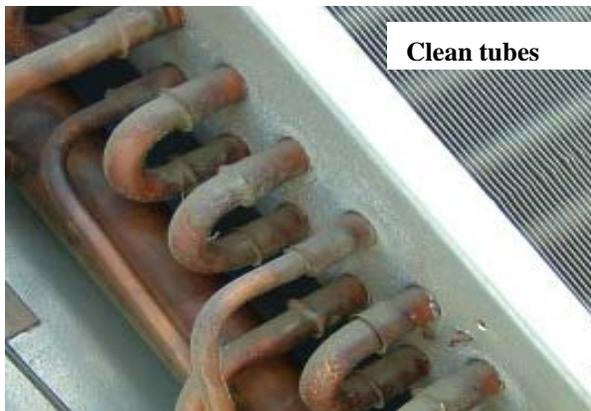
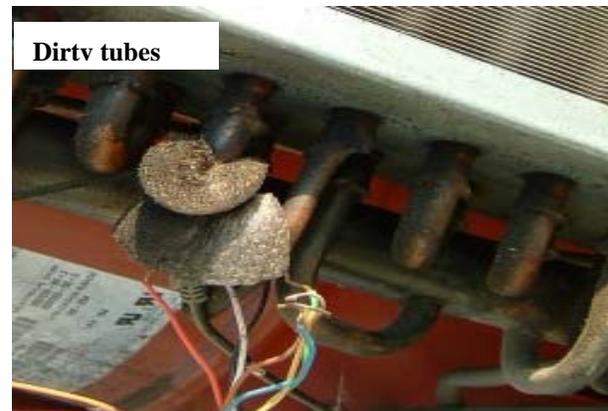
Fig. 12 Evidence of leakage occurring at the tube bends

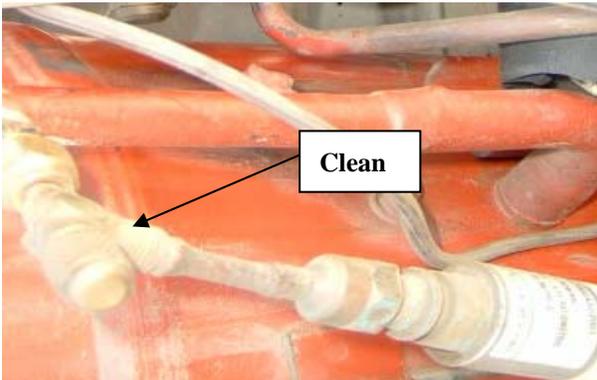
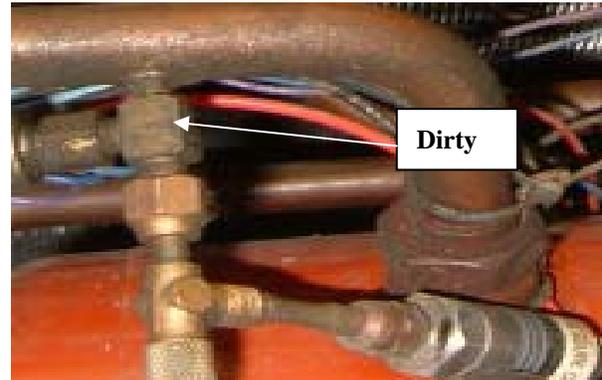
Fig. 13 Lubricant leakage

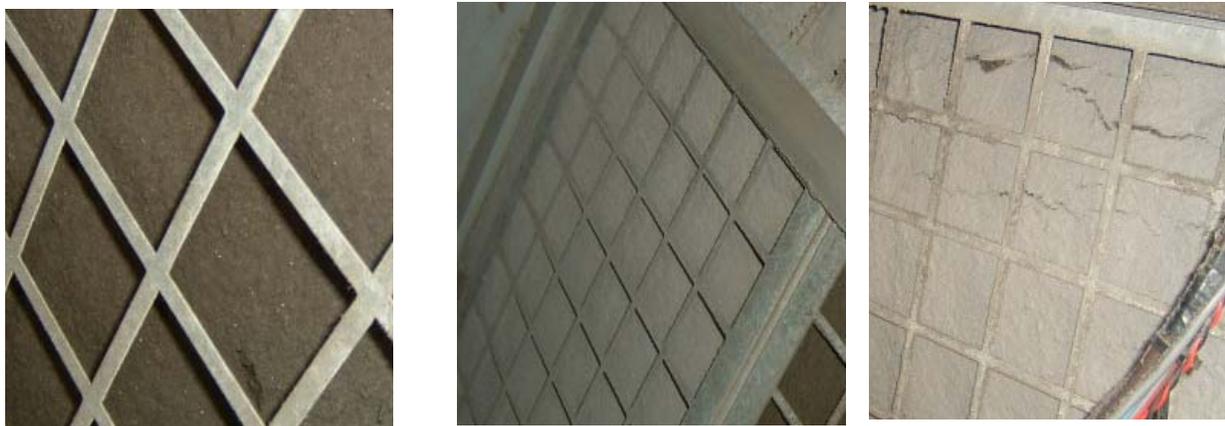
Fig. 14 shows several snapshots for evaporator air filter fouling which are taken from the Oakland fastfood Restaurant. It can be imagined that the air flow is significantly lowered for these cases, which confirms the previous diagnosis of a severe evaporator fouling. Evaporator filter fouling is quite common at the field sites, especially for the fastfood application. Another phenomenon is that filters of different RTUs at the same site had very different fouling levels. Some of them are very dirty as shown in Fig. 14 and others were lightly fouled, which means that regular preventive maintenance service is not ideal.

**Fig. 14 Evaporator air filter fouling snapshots**

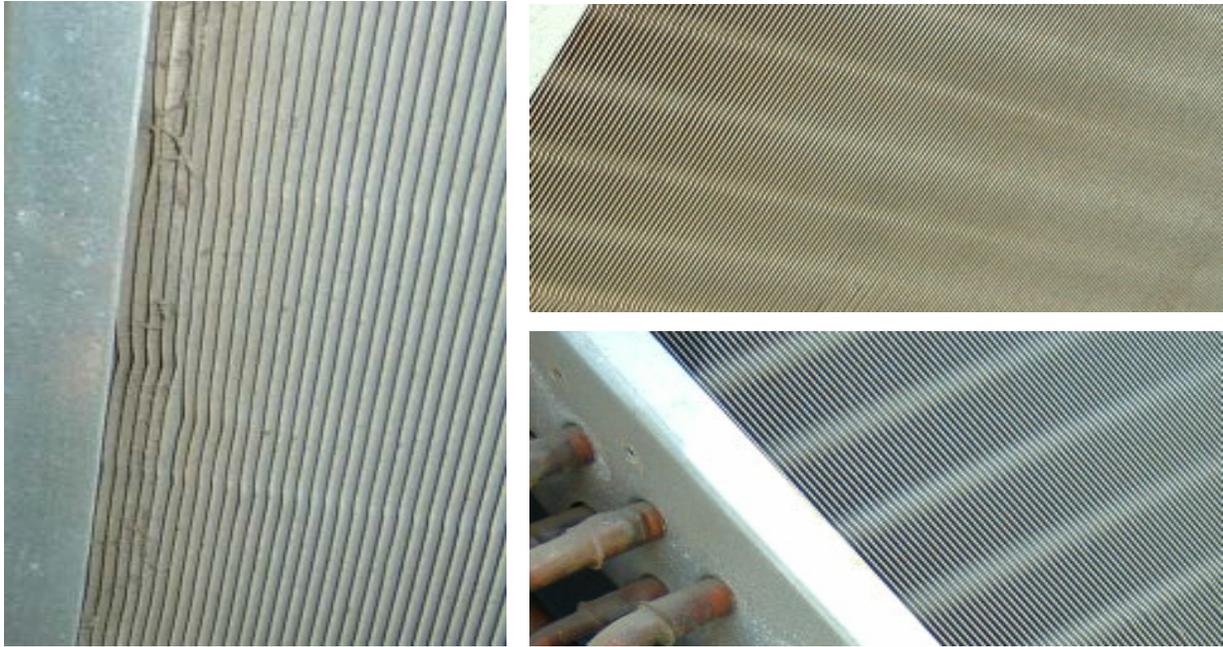
Unlike evaporators, condensers do not have air filters and fouling faults are not as obvious as those for evaporator filters. Snapshots shown in Fig. 15 are taken from different RTUs at the same site (Rialto Walgreens). Similar to evaporator air filters, some of them are clean and some of them are dirty. Liquid-line restriction faults are not visible unless the filter/drier is taken off and opened.

Fig. 15 Condenser snapshots
