Evaluation of a Decoupling-Based Fault Detection and Diagnostic Technique –

Part II: Field Evaluation and Application

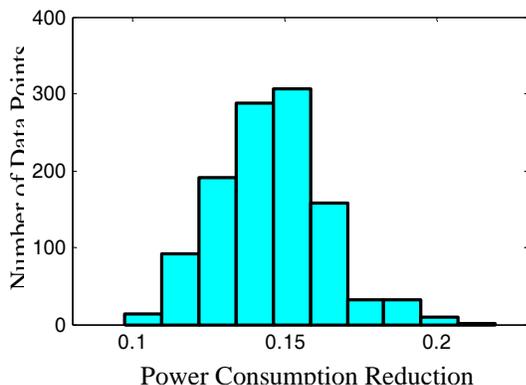
Fig. 10 Power consumption reduction distribution

Fig. 9 plots an economic criterion for service, EER degradation. It can be seen that the system EER degrades between about 10~40%, depending on the operating conditions. Compared with the cooling capacity degradation, the EER degradation is a little smaller. Fig. 10 plots the system power consumption reduction. The average power consumption reduction is about 15%, which is smaller than the average cooling capacity degradation of 32%. The average degradation in EER is 21%.
